# GIS UHF PD Measurement And Case Study

Jeon Hong Rok

Forum International Fisuel – Séoul / Corée du Sud – 04 et 05 Novembre 2015  
Fisuel International Forum – Seoul / Korea – 04th & 05th of November, 2015

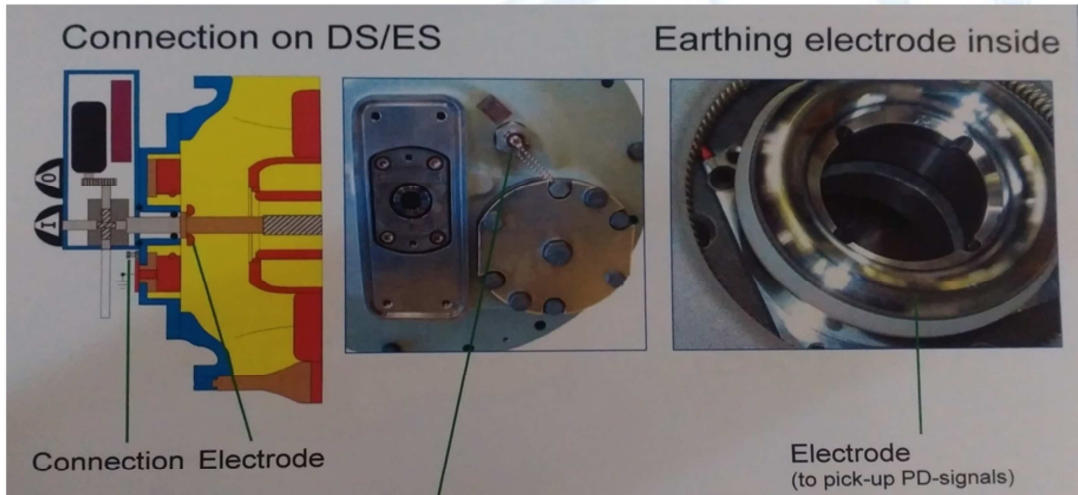
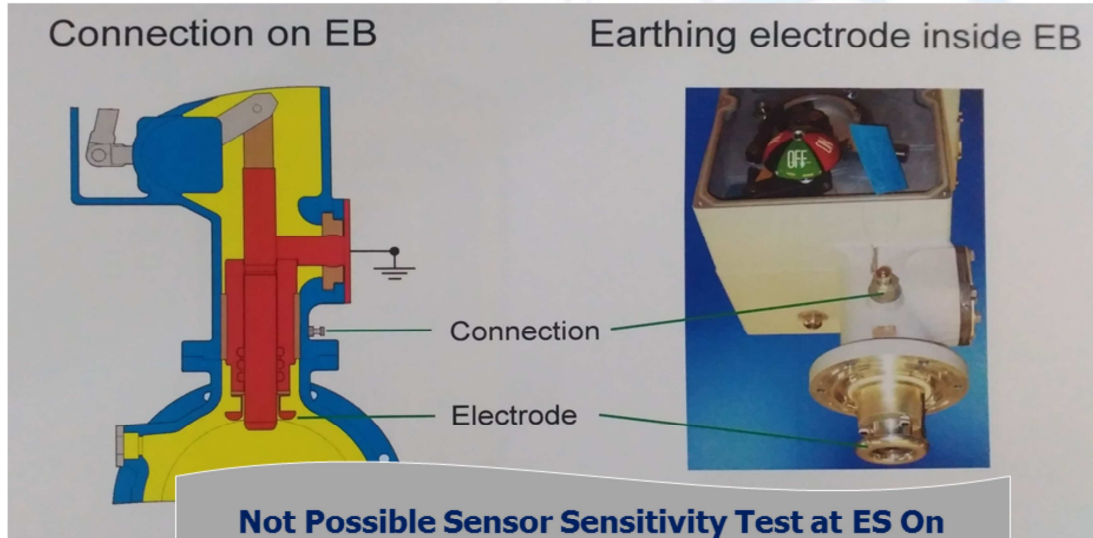
## ▣ Sensor Sensitivity Test Fail : ABB GIS

- Type : 220kV, 400kV
- PD sensor is located in earthing switch

- Earthing Switch and PD sensor
- Spare & CB Off bay ES condition : On

ABB feeder side PD sensor is located fast earthing switch.  
Spare and CB off bay's ES condition is On.. That time not possible  
sensor sensitivity test

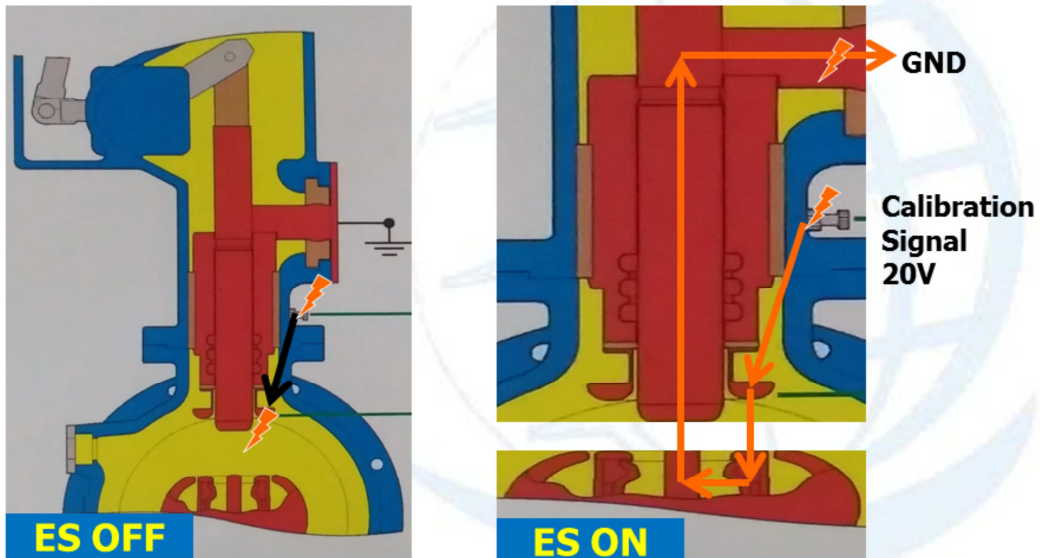
• Reason : Electrode is connect to GND at ES on condition

Because of PD sensor is connect to ground while ES on

Compare ES condition on and off

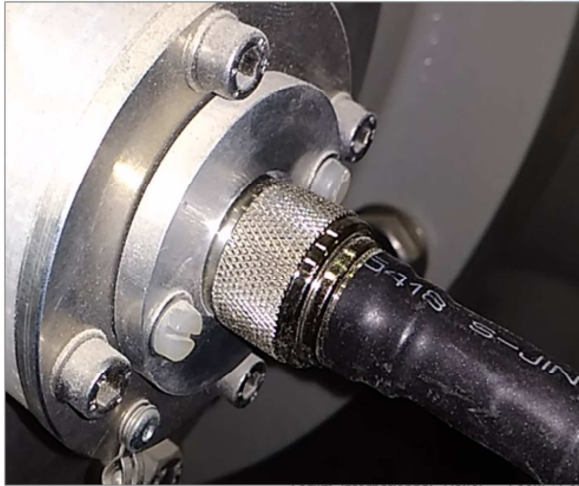
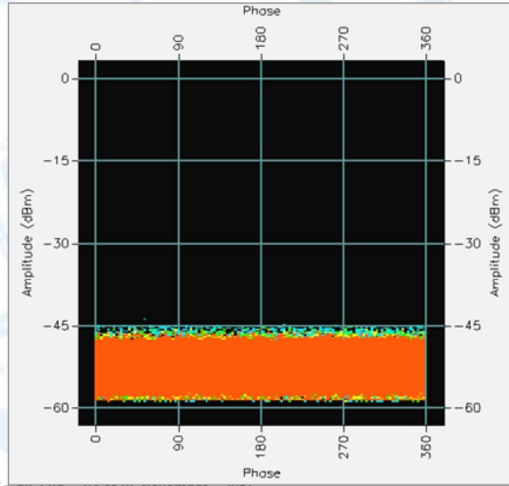
## ▣ Sensor Sensitivity Test Fail : AREVA 66kV

- Location : Doha Super
- Consider : Sensor connection and heavy noise

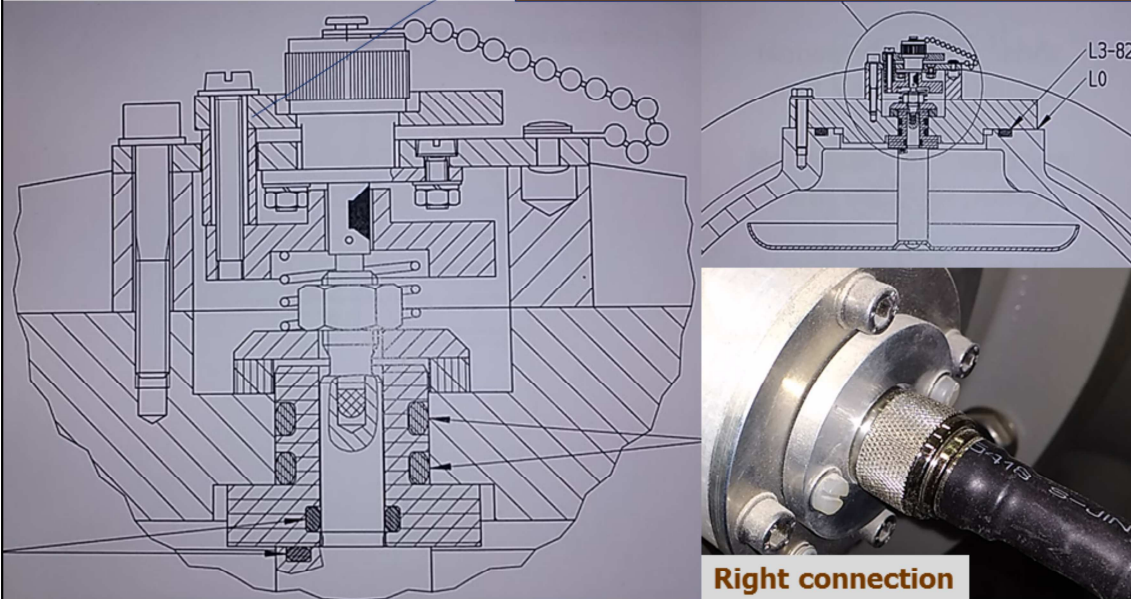
● **Sensor connection**

**Automatic earthing device**  
When cable or shorting cap are removed

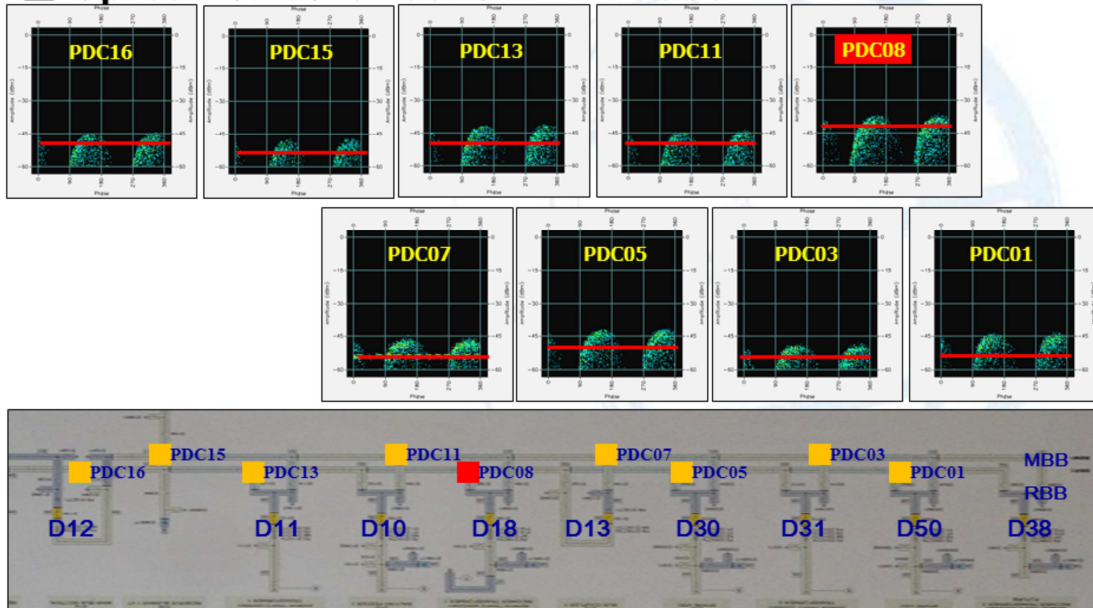
■ Spread to other sensor Y Phase

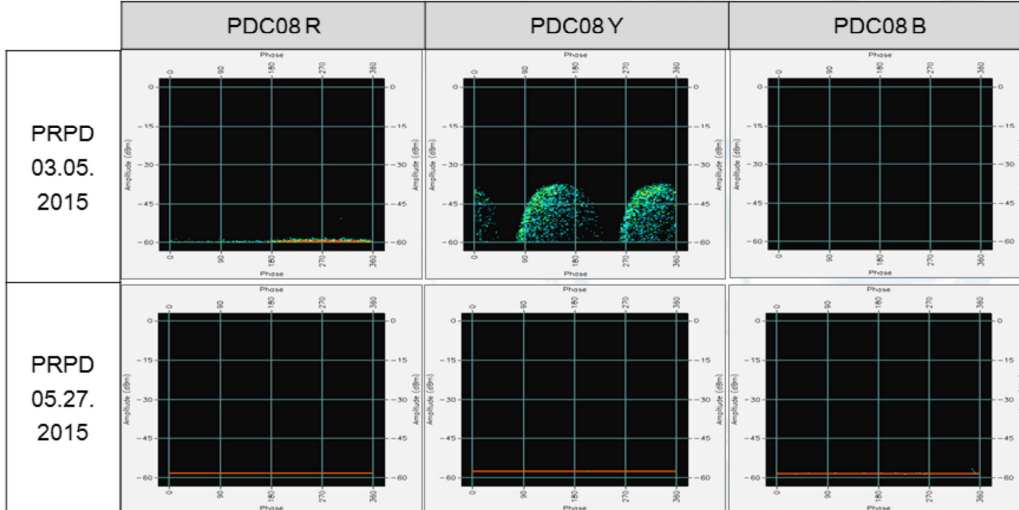
■ **After Transformer overhauling**

● **After CB On : PD signal is not detected**

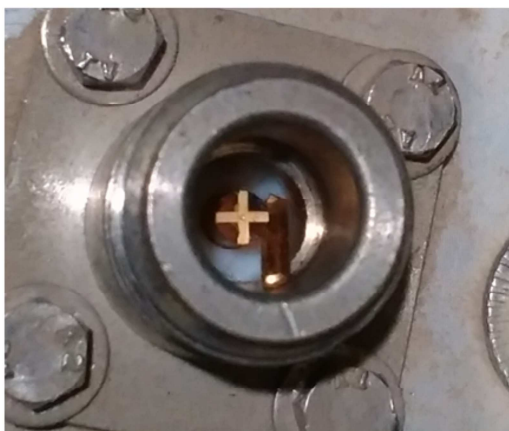
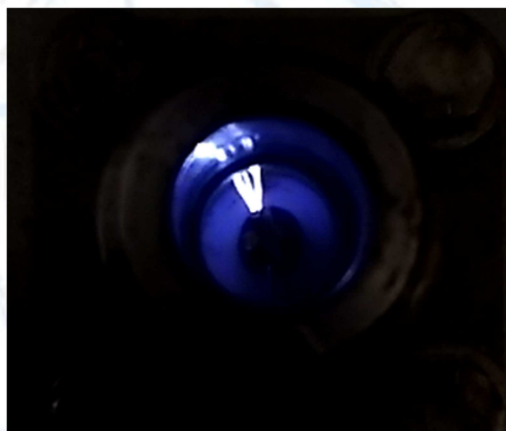
## ▣ D502 R Phase

- **D502 R Phase sensor broken**
- **When closed sensor, center pin is connect guide.**
- **This arcing signal spread to near other sensor**

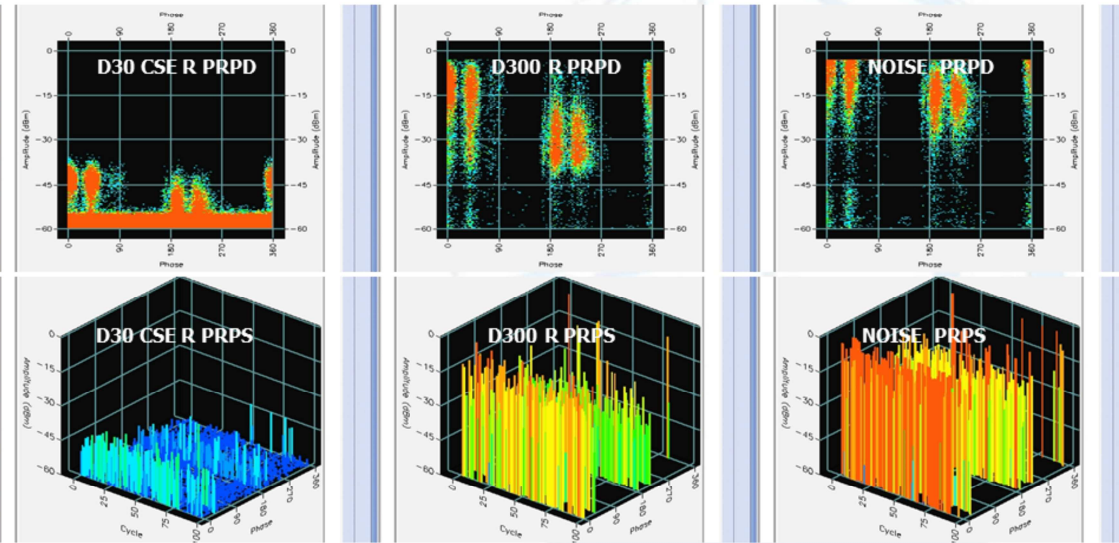
## ■ PRPS & PRPD : Noise Gating Off

- D300 R : Similar PD + Arcing
- D30 CSE R : Arcing

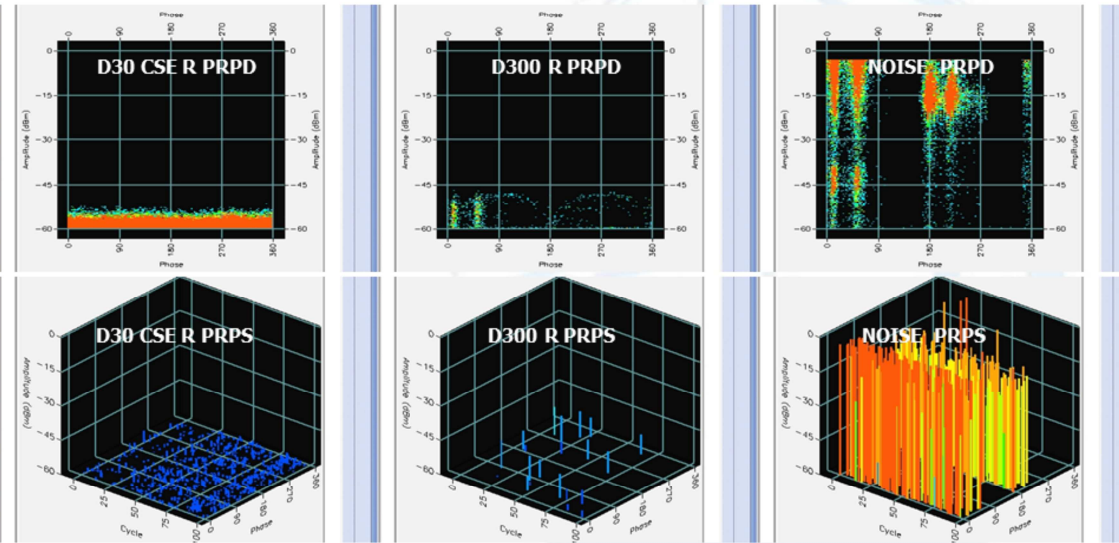
## ■ PRPS & PRPD : Noise Gating On

- D300 R : Similar PD + Arcing
- D30 CSE R : Arcing

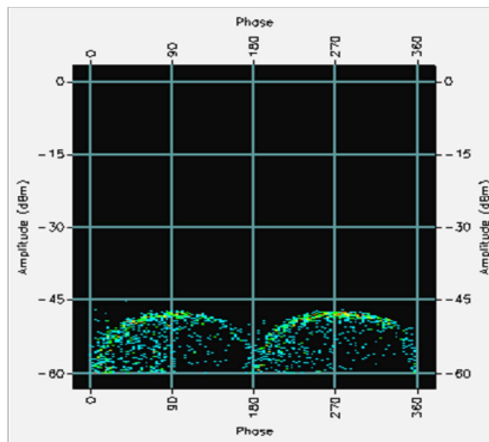
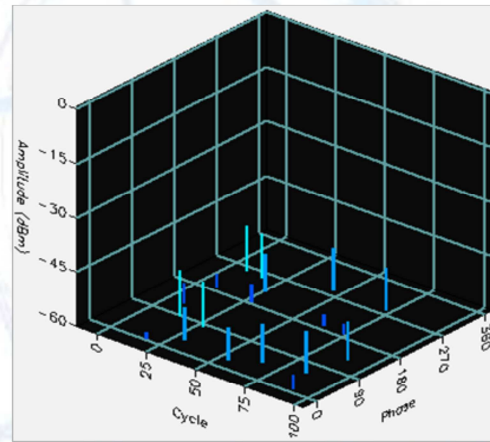
## ■ Test Result

- **D502 R phase sensor broken and occur arcing**
- **Remove arcing signal and only remain PD signal**
- **Test Result : Particle**
