# GIS UHF PD Measurement And Case Study

Jeon Hong Rok

Forum International Fisuel – Séoul / Corée du Sud – 04 et 05 Novembre 2015  
Fisuel International Forum – Seoul / Korea – 04th & 05th of November, 2015

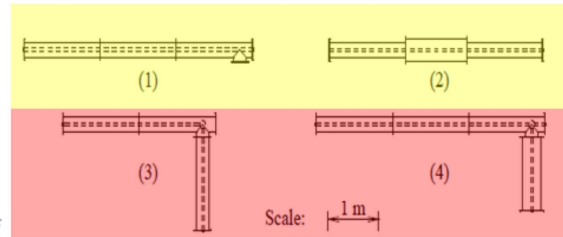
Fig. 7 Four configurations of the 132 kV GIS test chambers.

- A uniform straight GIS section of up to 4.5 m in length appeared to be loss-free. In some instances slightly more
- Signal power measured in a side compartment (such as a corner or T-junction) at 90° to the chamber containing the source was in the range 5-9 dB below that in the main chamber. The termination of the side compartment had a

Because of bus section is include angle point..

Usually straight section is not attenuated up to 4m ..

But PD signal is attenuated 5 to 9dB per angle and T-junction

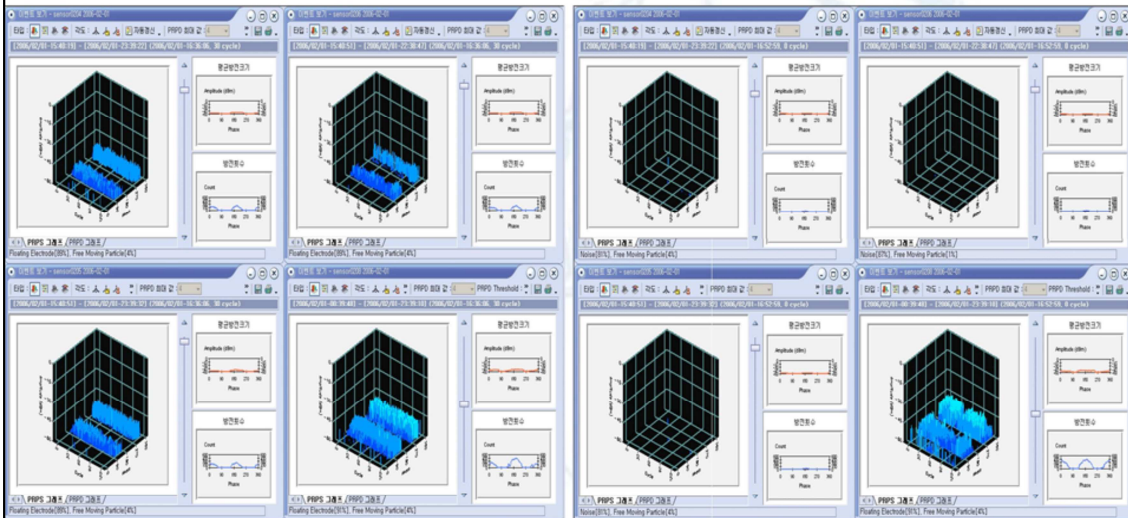
[Before Noise Gating]

[After Noise Gating]

**• Noise gating method is very effective for noise reduction**

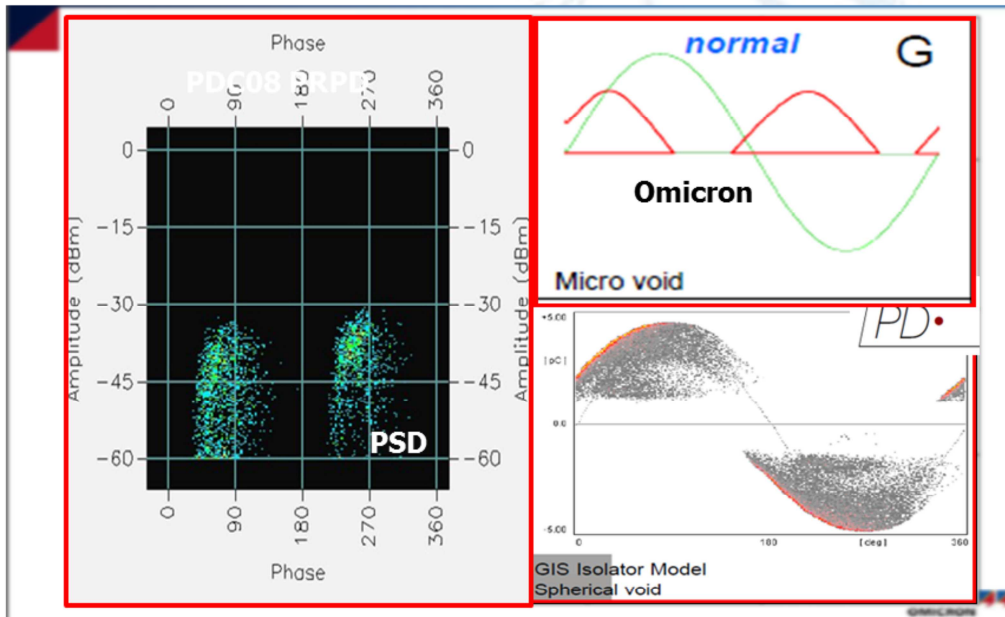
## ■ Analysis

■ **After Transformer overhauling**

● **After CB On : PD signal is not detected**

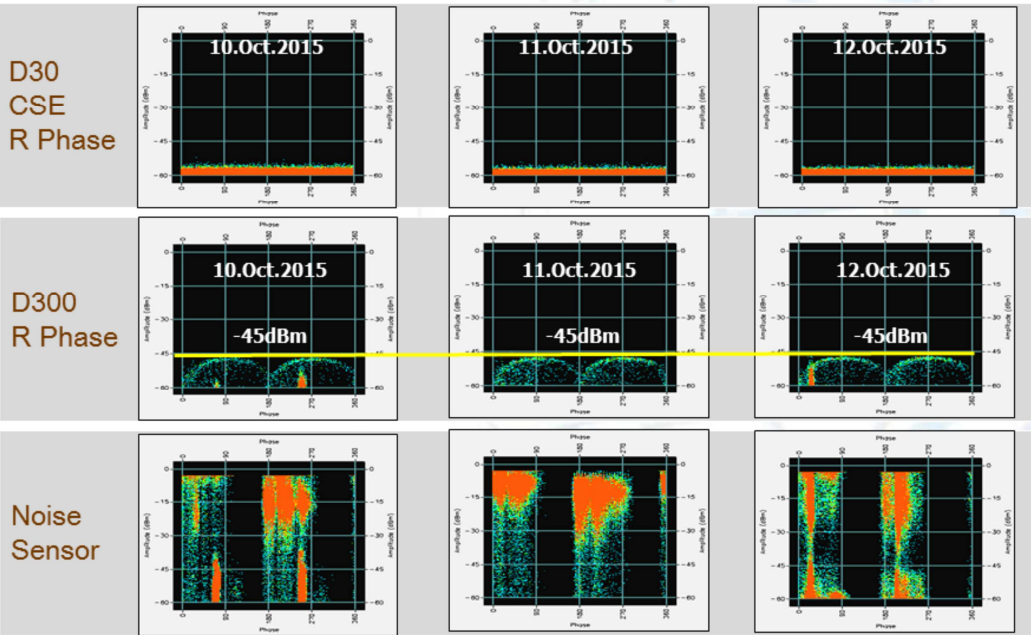
## ■ PRPD : 1<sup>st</sup> Day, Noise Gating On

- **D502 R phase sensor broken and occur arcing**
- **Remove arcing signal and only remain PD signal**
- **Test Result : Particle**
