# Statistics

# Spain

**Presenter:  
Enric Fajula**

**Deputy Technical Director at AFME**

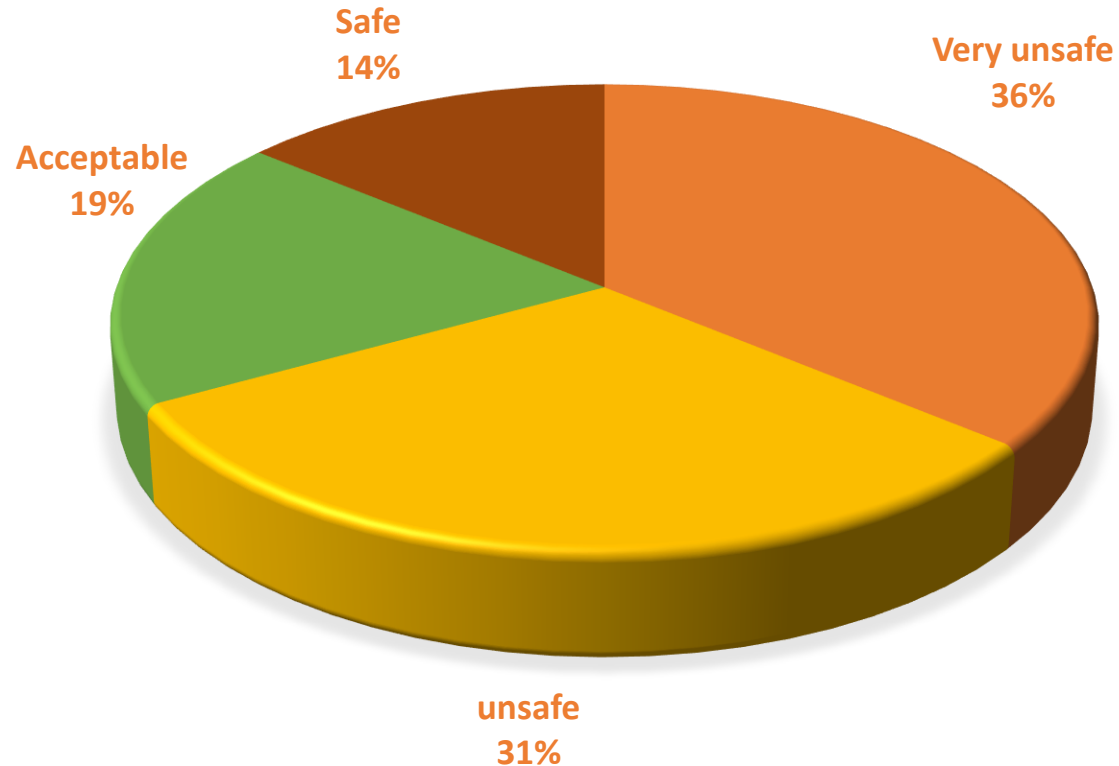
- ✦ Study prepared by AFME and published in 2000 by AENOR
- ✦ To know the state of the electrical installations in dwellings
- ✦ Sample of 762 dwellings distributed throughout Spain.

## State of electrical installations in Spain

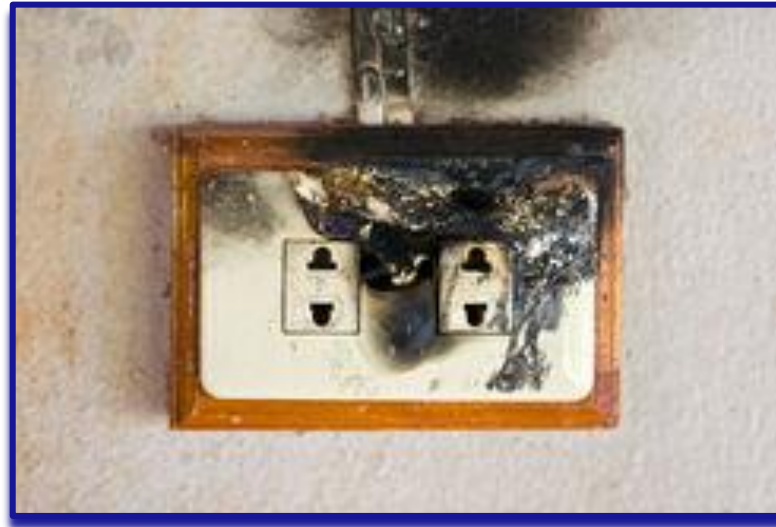
## Installation without protective conductor

Risk of electric shock

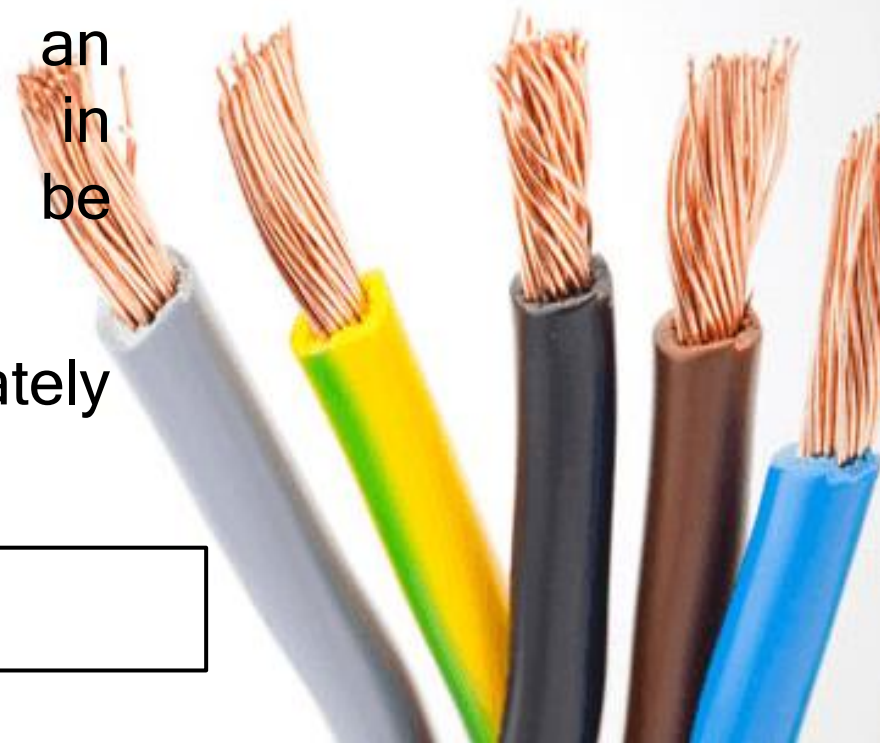
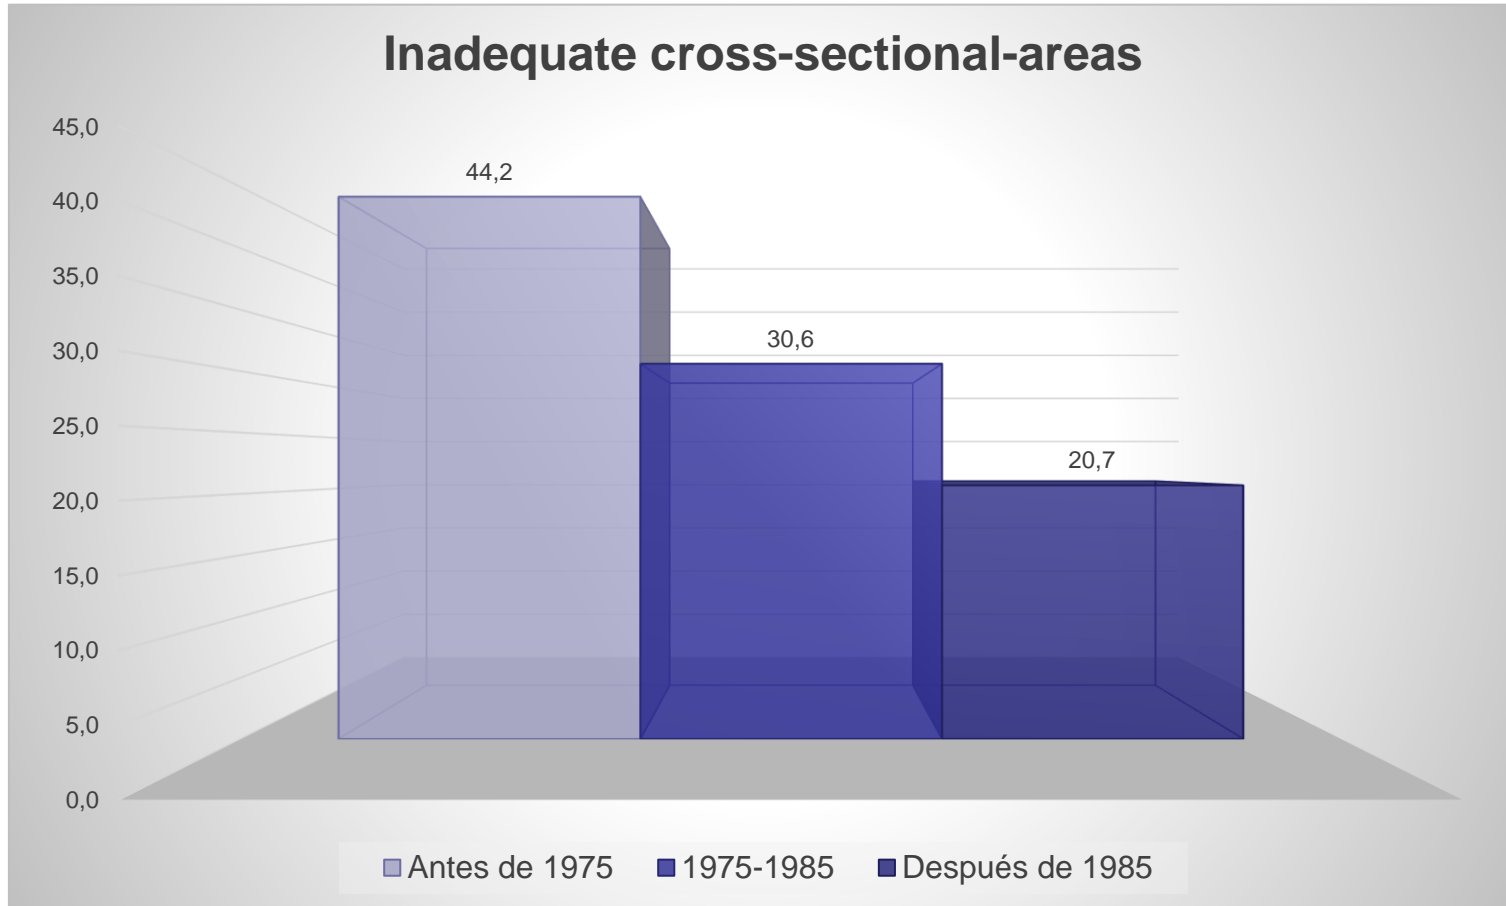
## Inadequate cross-sectional-areas

- ❖ Conductors do not have an adequate cross-section-area in accordance with the load to be supplied
- ❖ Conductors are not adequately protected against overcurrent

**Fire risk**

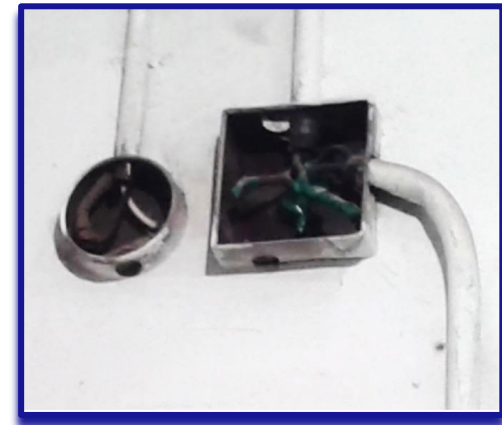
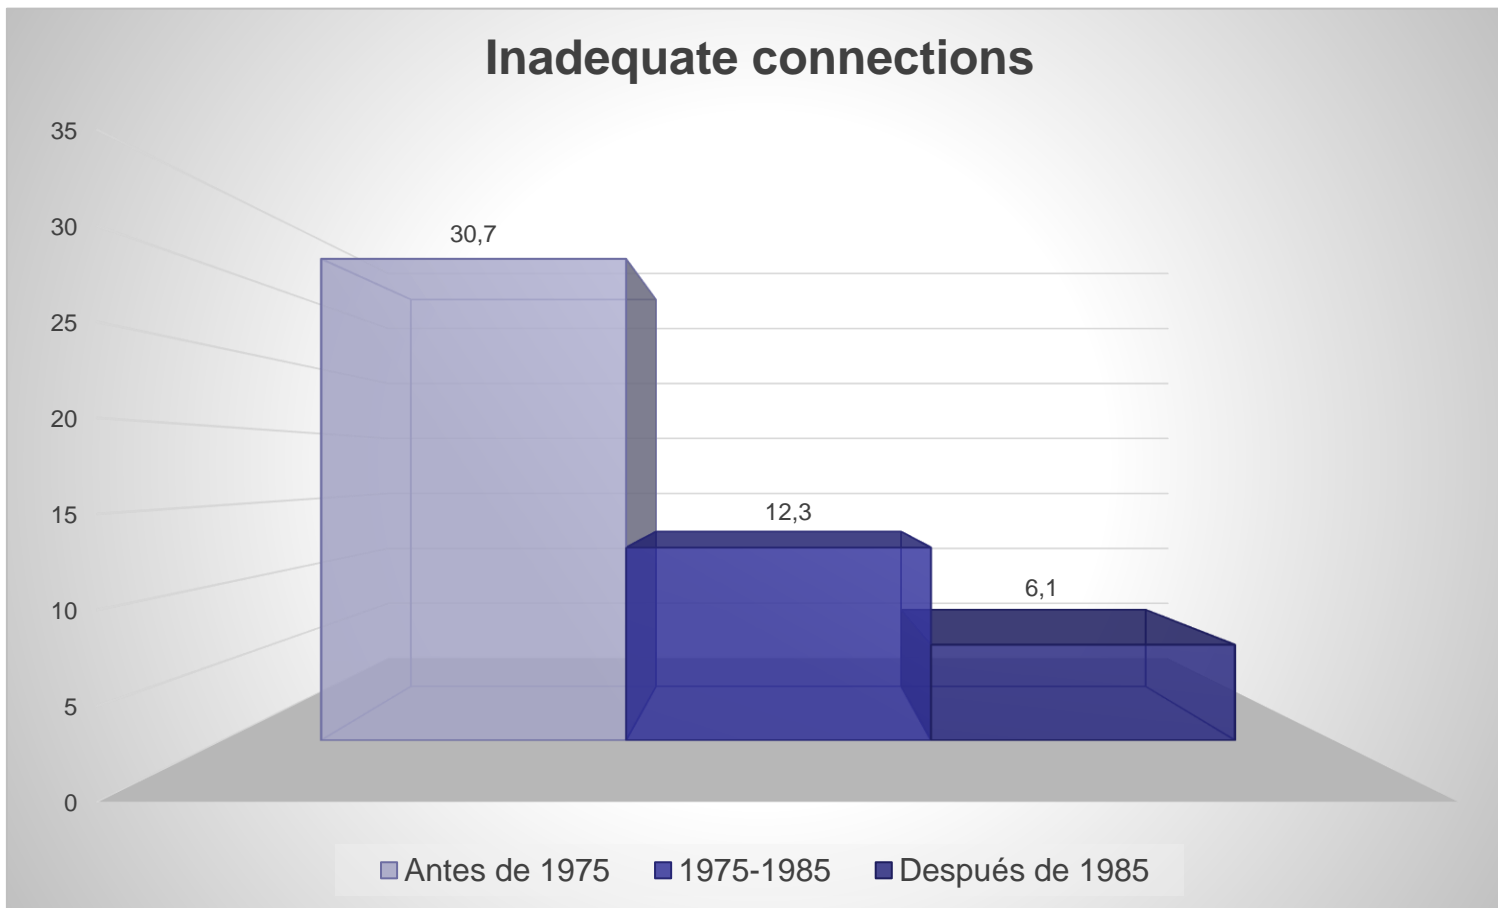
## Inadequate connections

- ✱ Connections made without the appropriate connecting device
- ✱ Junction boxes without cover

**Risk of fire and electric shock**

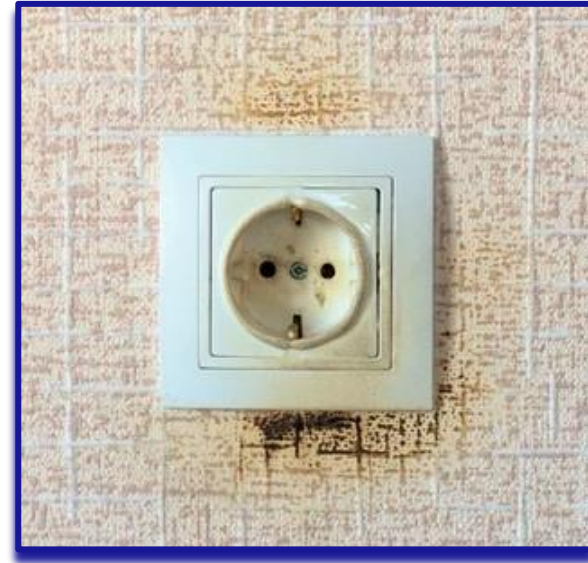
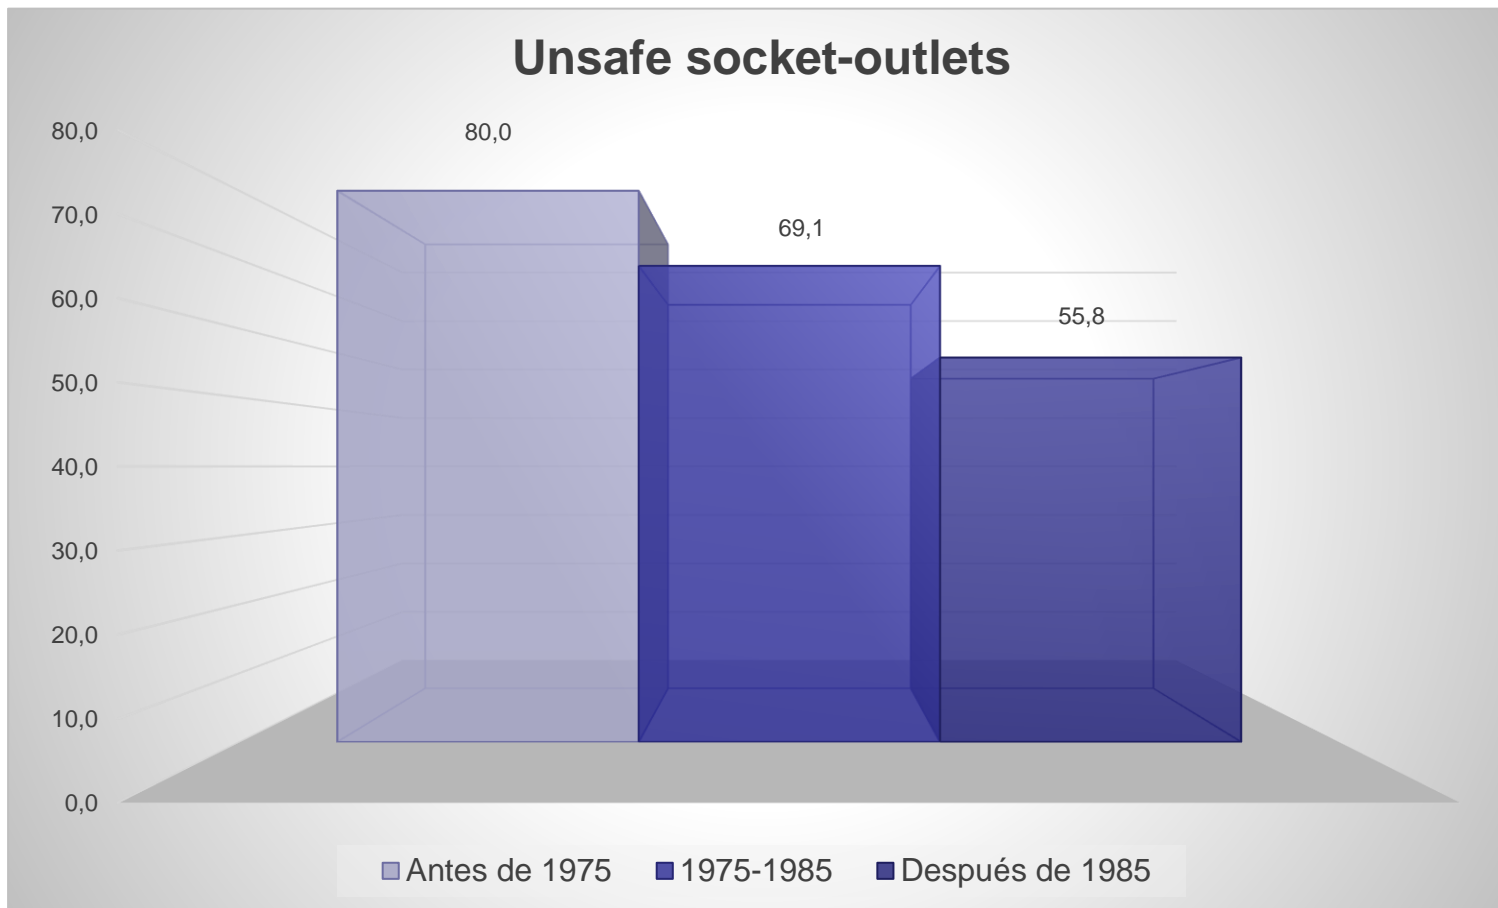
## Unsafe socket-outlets

- ❖ Socket-outlets without continuity of the protective conductor (earth)
- ❖ Socket-outlets in poor condition

**Risk of fire and electric shock**

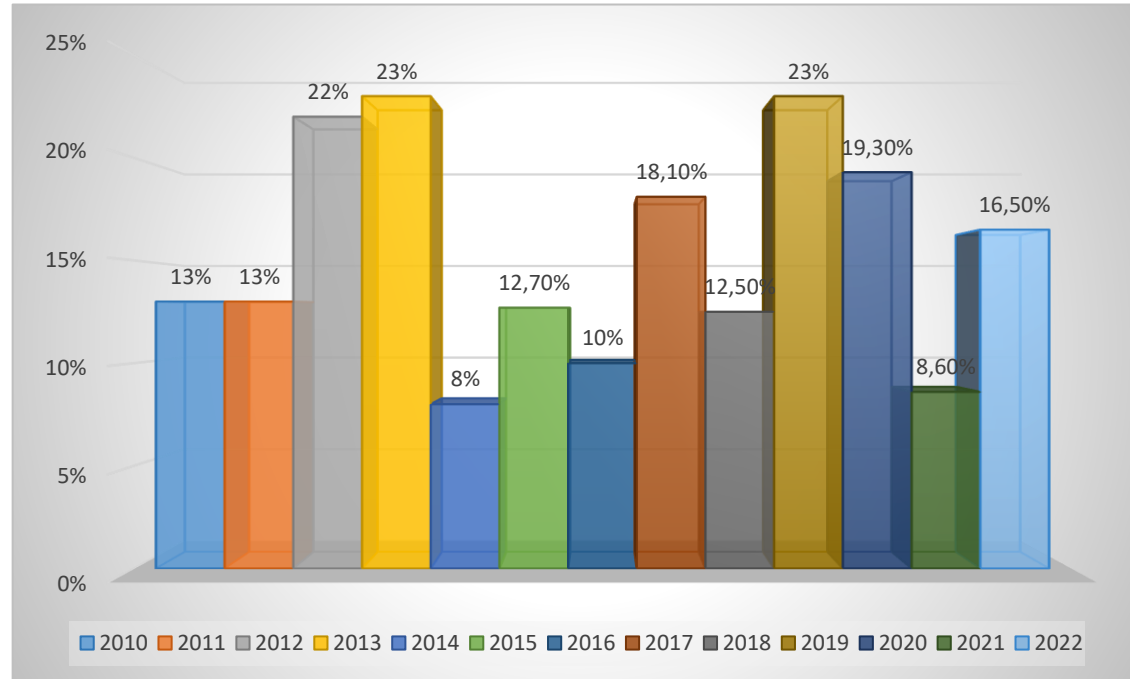
**Electrical origin:**  
Appliances, sockets, adaptos  
or extension cords

**Fatalities in dwellings where the probable cause of fire is electrical.**

**Source: Fundación MAPFRE-APTB Studies**

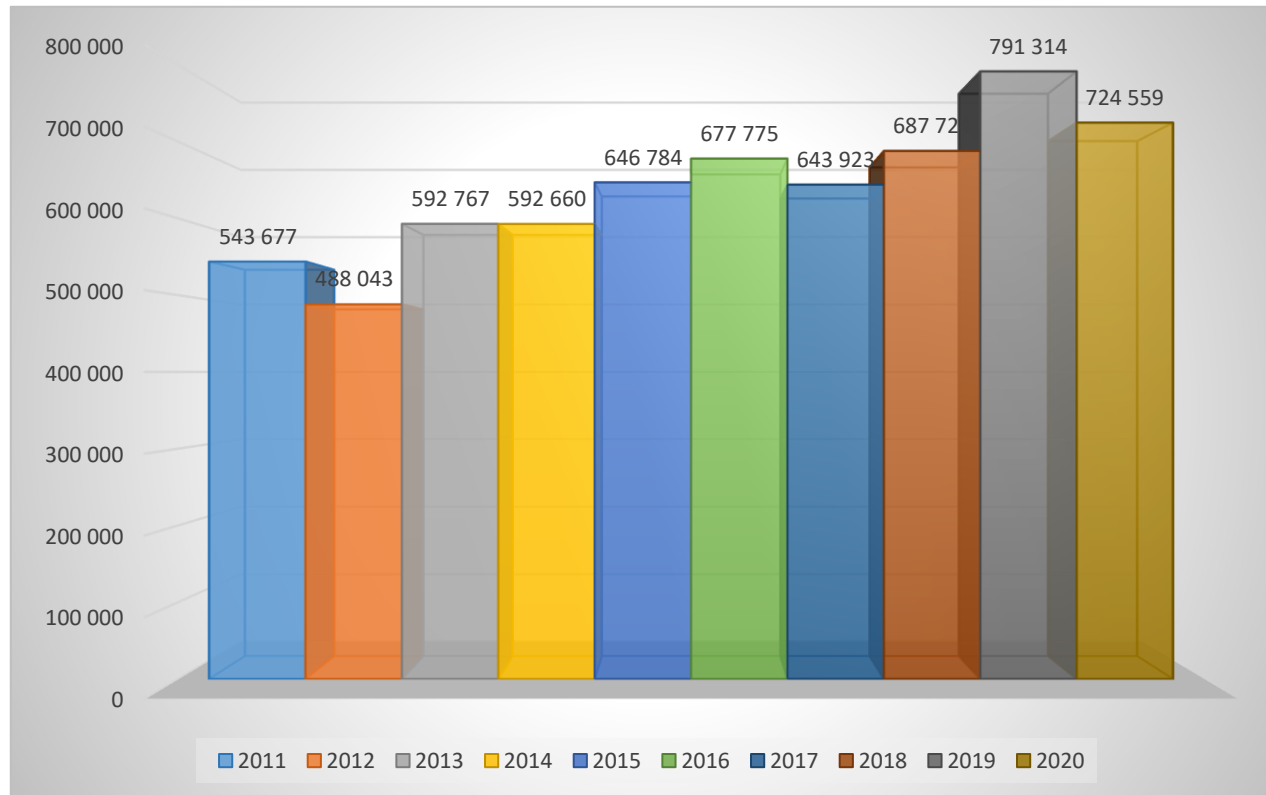
Electrical accidents in dwellings.

Source: UNESPA
